Advanced Training Programme
on
Conservation and management of Historic buildings

Proposal on Conservation

“Musya Bahal”

Rupa Dongol
Kathmandu Metropolitan City
Kathmandu, Nepal

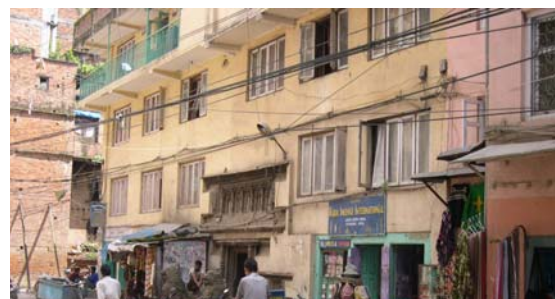
Plate 10: North wing showing facade

It is now a four storied building. Its wall is cement plastered and painted in yellow colour. The wing is divided for two families with a stair case, toilet and other utilities. *No additional structural system has been used to strengthen the foundation* which has been directly built above the old structure. In the ground floor five shops occupy road side front.

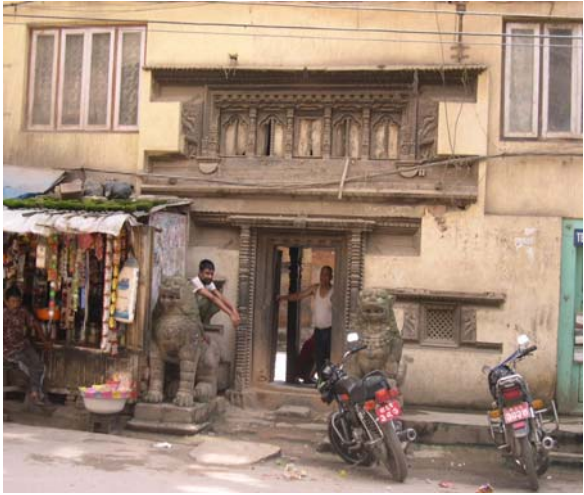
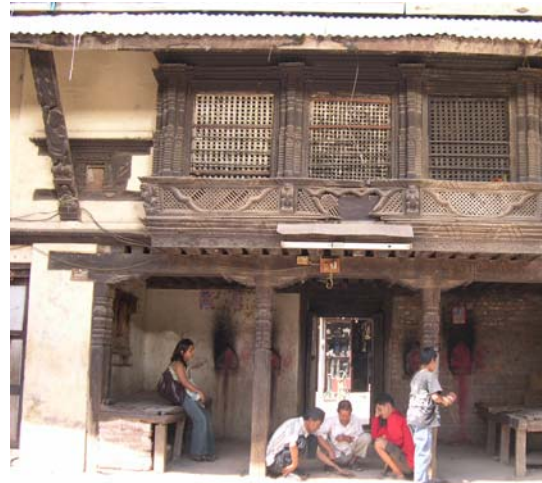
Plate 11: Only remaining old elements from outside and court face respectively

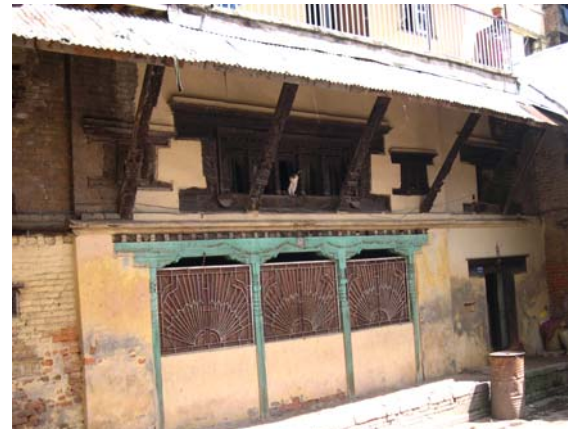
Eastern wing is a three storey building in plaster and yellow colour finish. Cantilever balcony over hangs on the outer court. The *Dalan* on the eastern sides has been privatized, closed and used as a room. The only evidence of it being a *Dalan* in the past is the lattice window and the *Dalan* pillars. The first floor still has the old window as it has to be. Part of the old roof still exists except that it is covered with CGI sheets now.

Plate 12: Closed dalan, additional roof and old elements

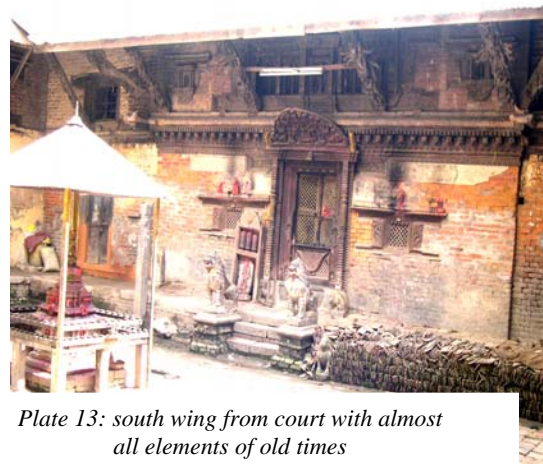
Plate 13: south wing from court with almost all elements of old times

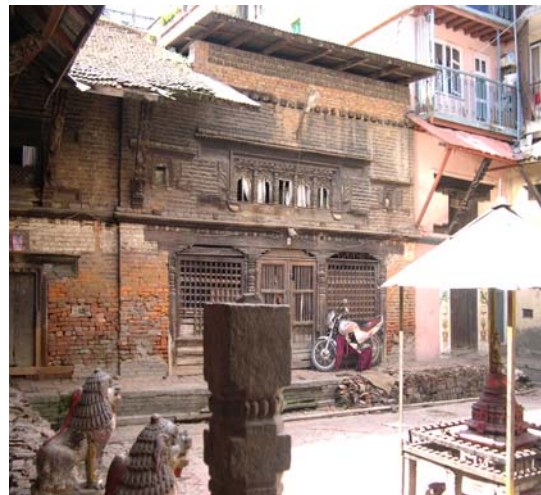
Western wing looks like a mixture of the old and the newly constructed parts. The northwest corner has two added storey with cement plastered wall and a flat RCC roof. In the south west corner room, a door to access the toilet by the family living in this wing has been added. The *Dalan* is being used as a store room closed from the courtyard and its entry is created from the south west corner. In the past these *Dalans* were used to display the accessory of gods and goddess (*Bahideyo*) after Gulan festival but these functions are totally lost today.

Plate 14: West wing from court showing mixed facial character.

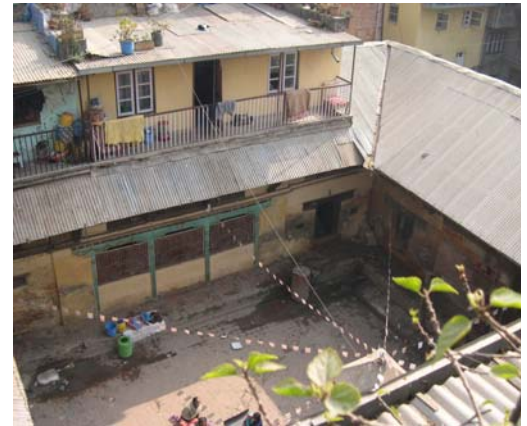
- Roof has been totally demolished and extra two floors have been added.
- Some portions are still remaining but they are covered by CGI sheets.
- Extra horizontal supports have been provided to support the roof overhang on the first floor.

Plate 15: just a sign of position of slope roof in first floor

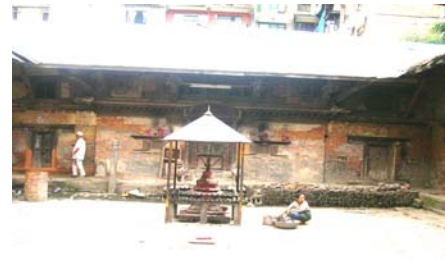
- The roof has a single pinnacle gajur made up of brass at the top.
- It has been covered by CGI sheets.

Plate 16: original form with CGI roofing

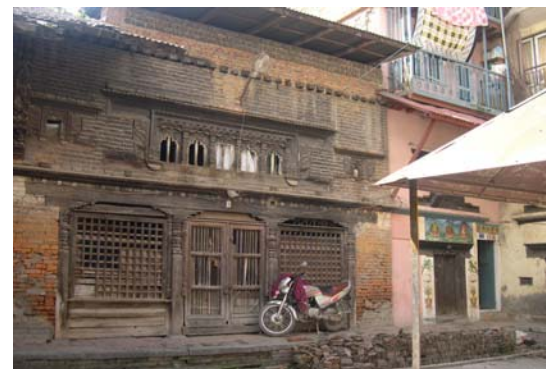
- The roof is divided into three parts.
- The roof level varies as in the North West corner due to the added storey, roof is a flat RCC roof.
- The south west corner has the original roof level but has been badly damaged and is a mixture of *Jhingati* and CGI sheets.
- The roof level at the centre goes about two feet up from the original level and is a flat roof covered by CGI sheets.

Plate 17: Multi level roofing

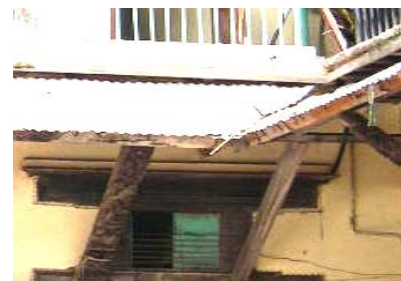
- Among the six carved struts, two struts on the each ends are missing.
- The existing struts are not well maintained and preserved.

Plate 18: Missing strut replaced by ordinary

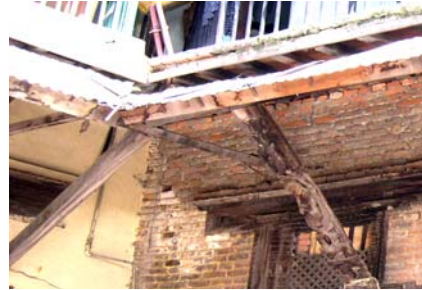
- Among the eight struts, one strut is missing.
- The existing struts are not well maintained, the hands of the gods and goddess on the struts are missing.

Plate 19: Missing strut replaced by ordinary timber

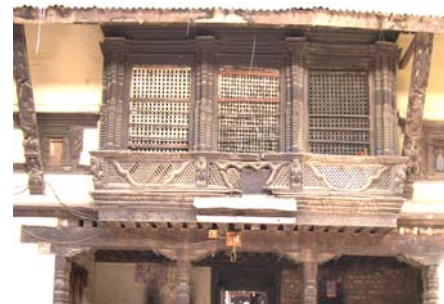
Plate 20: Existing ribbon window and Viman window from out and inside court respectively.

- The central *Biman window* is almost in a good condition except for some parts being broken. and it is projected about 2 feet out from the face of the wall.
- In the exterior façade all the traditional artistic ordinary windows.
- Small *Tikki Jhyas*(lattice window) on the either good condition.
- The large *Tikki Jhya* on the either sides of the façade are in good condition.

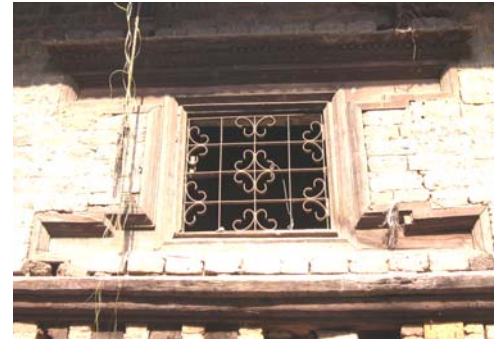
in the left side window is replaced by a metal grill.

Plate 21: wooden lattice replaced by metal grill

1. Plastered walls can be modified to show brick façade.
2. CGI roof can be removed to use jhingati tiles.
3. Big glazed windows and doors can be modified to the openings with comparatively small glazing.
4. Upper floors of the concrete additions are to be converted to two way sloped roof (dominating element of Nepalese architecture).
5. Details like cornice, struts etc are to be considered.
6. Iron grills in the windows are to be replaced by timber lattice windows.
7. Iron grills in the verandah are to be replaced by timber work or iron grills can be made to look as wooden.

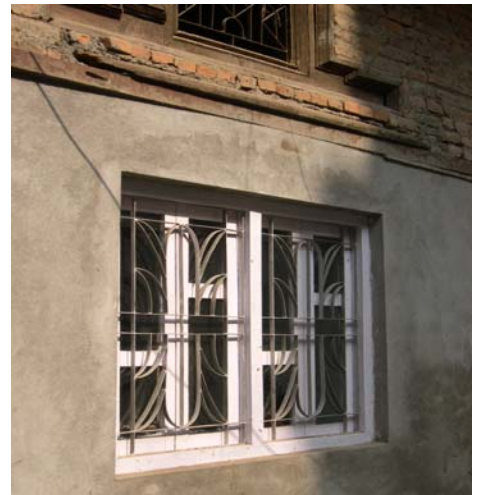
- The inner lattice work of the five bayed *Pasuka Jhya* in the centre of the first floor and the small *Jhyas* on the either sides has been replaced by glass which is now in a broken state.
- The upper half of the lattice work of the two other *Tikki Jhyas* placed at the corners at the either sides have been cut, the one at the right is left open whereas the left side window has an inner metal net.
- The two big lattice windows on the ground floor have missing frame and minor broking.
- The second and third floors at the north east corner have modern windows and door.

Plate 22: addition of new openings

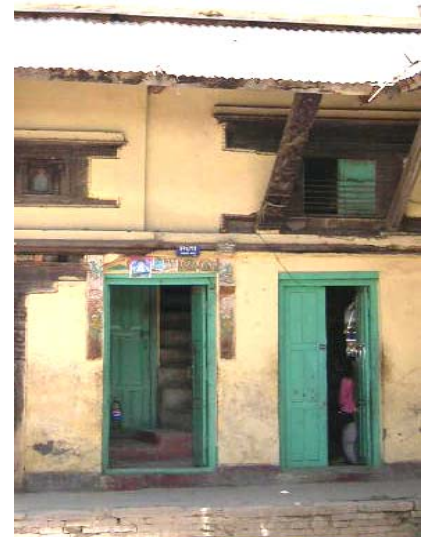
- There are two doors on the either sides of the ground floor.
- The lintel of the door on the left side has been cut to accommodate a small window.
- The door in the right side is almost in good condition.
- Both the doors have lost its panels.
- Extra doors have been added to the exterior façade of this wing.

Plate 23: Addition of new openings

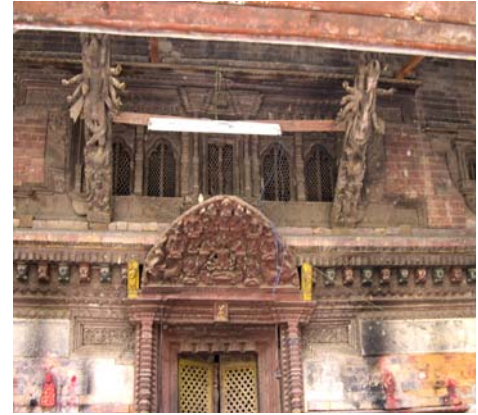
- The main door to the shrine on the ground floor is in a good condition except for some minor lattice work damage.
- There are two doors on the either sides of the main door with modern metal locks.
- The door at the right side is a traditional door which is in a good condition.
- The door at the left side is a modern paneled door.

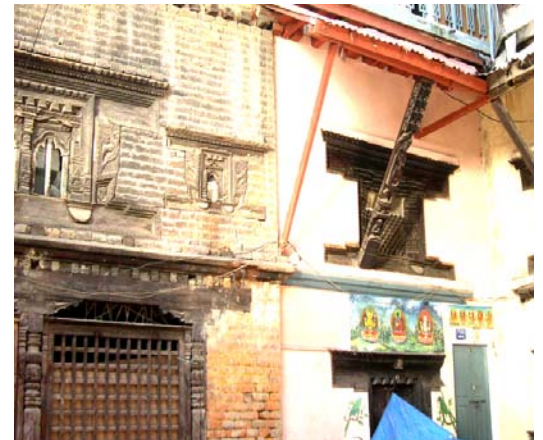
Plate 24: fair condition doors and windows

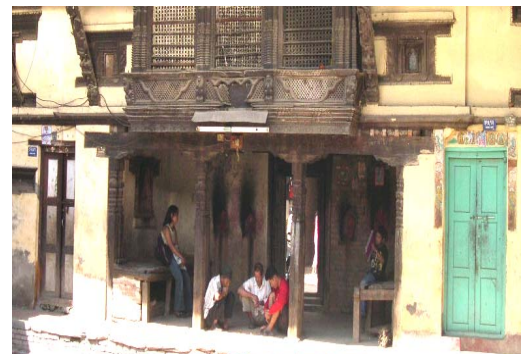
- The *Dalan* in this wing is fairly in good condition.
- It has all the traditional looks and character of the Bahal.
- It is still used by the locals as a chatting and gathering area.
- The niches in the Dalan have been some what altered.
- The holes in niches have been reduced.

Plate 25: fair condition dalan

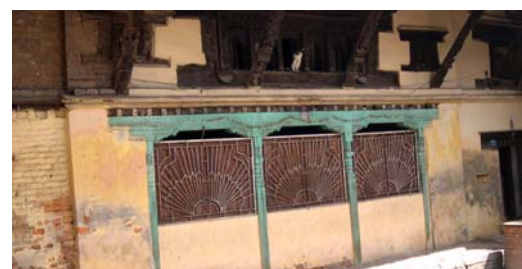
- The existence of the Dalan can hardly be felt.
- It has been covered, walled and privatized.
- Only the columns and the lintel portray that it was a Dalan before.
- The social, cultural and the physical character of the Dalan have been totally lost.

Plate 26: dalan with iron grill and partition wall to accommodate living space

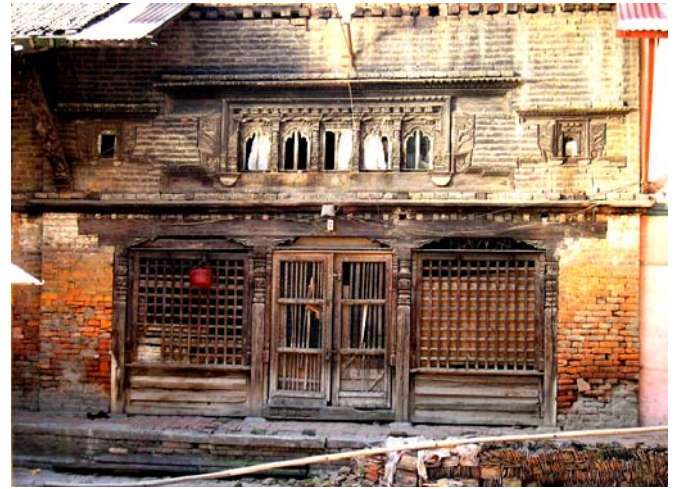
- The Dalan has been closed by a door and fixed wooden windows.
- The Dalan has lost its original function and being used as a store.

Plate 18: fair condition dalan with changed function

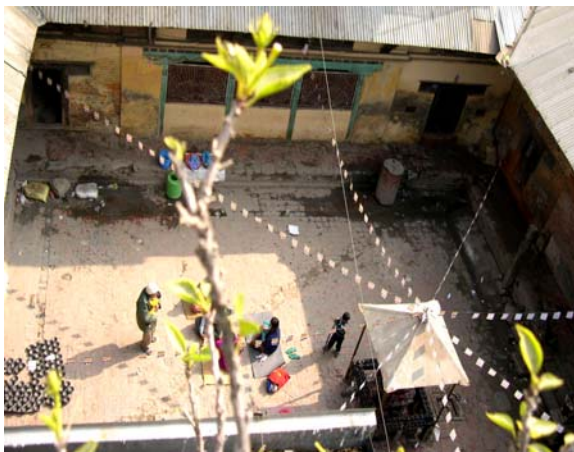
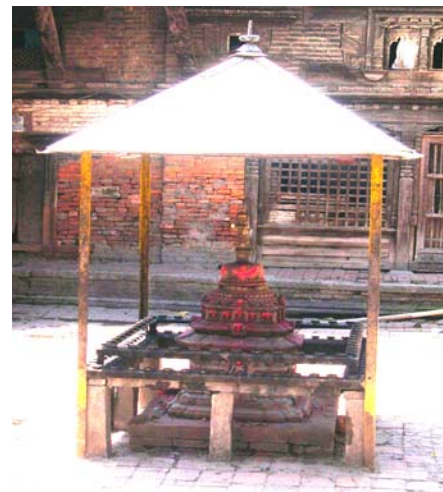
- The courtyard is a square (12.60sq.m)
- It is 45cm below the plinth level
- Chaitya is located in the main axis of the court.
- The sides of the court have drain and drain out hole in the south west corner.
- The drains are not working properly due to the drains being blocked.
- The court is constructed of oiled bricks and mud mortar previously but now days instead of mud mortar cement mortar is used.
- A walk way of 105cm is provided around the plinth.
- A hole dedicated to Lukumahadyo has been added in the court which was not present previously.
- The tiles of the roof are also stored in the court.

- The Chaitya is fairly in good condition except for the cracks in the *Chattri* (roof).
- It is covered by CGI roof to prevent it from the weathering affect.

Plate 27: Court and Chaitya
